PROJECT: RESIDENTIAL DECK JOB SITE REPAIR

DATE: NOVEMBER 2013

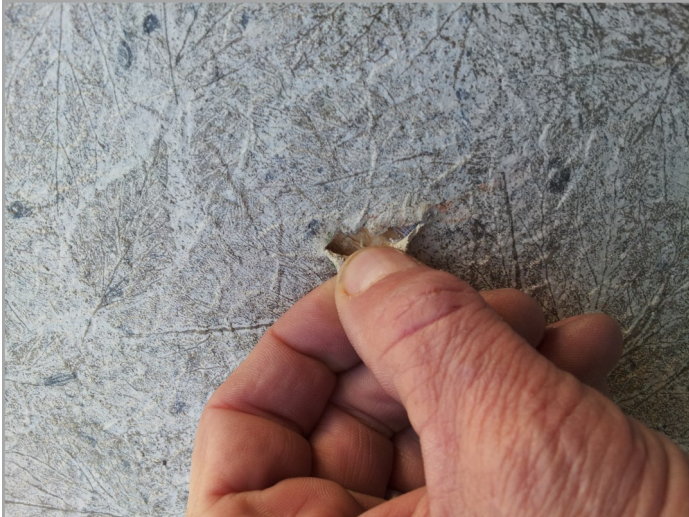
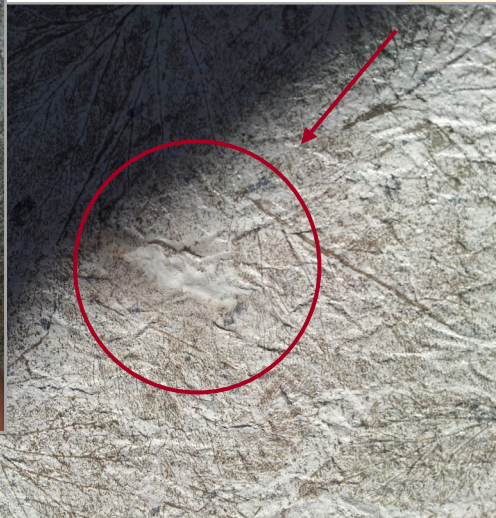
The next day when work continued on the job site and the windows were being installed, the contractor dropped the 2x8x8 inch frame which landed on its sharp corner, tearing the membrane and making a 1/8" dent in the plywood—compromising the waterproofing and leaving a visual flaw.

He cut a small piece of Duradek vinyl membrane to fill the dented area, cut open the torn area to insert the patch piece and heat-welded the affected area.

With a lower heat on the hot-welding gun, he simply melted the two layers of vinyl membrane together and used a roller to press it all together.

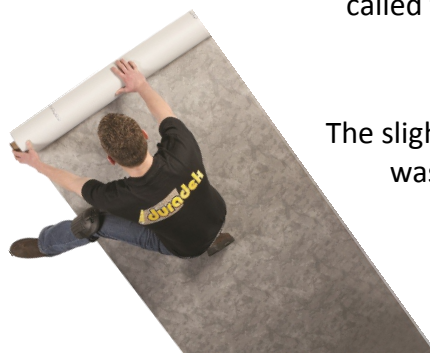
The result, a barely noticeable visual difference and an uncompromised waterproof membrane!

The slight imperfection left from the repaired damage was very minimal as compared to other products like a liquid or fibre glass coating which would have to be mixed on-site and very difficult to match to the original tone being repaired.
