CASE HISTORY # 159

PROJECT: ROOF DECK RESCUE, ATLANTA, GA

DATE: APRIL, 2014

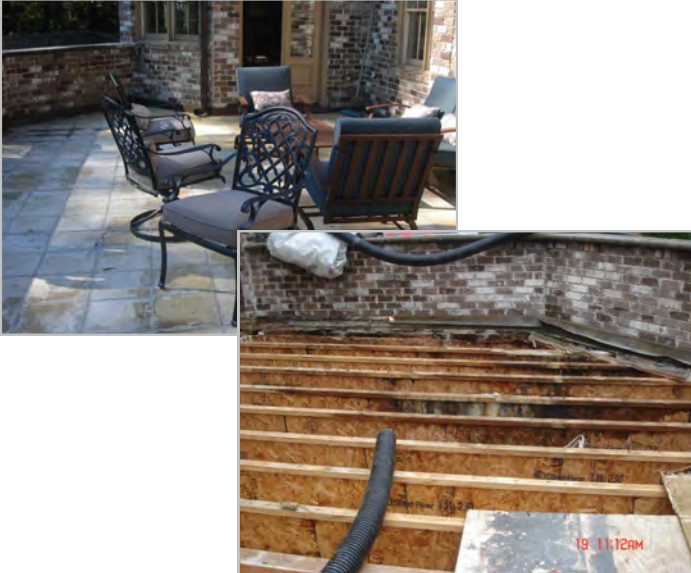
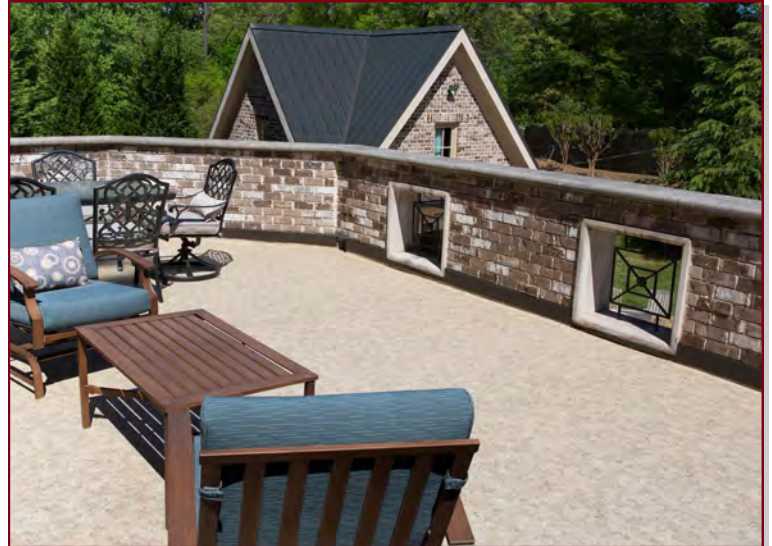
This tile deck was leaking into the lower level of the home but the homeowner was not sure what to do to solve the problem. They had tried a variety of products to stop the leaking including sealers, caulk and Finley tarps. It was when the homeowner found an area that was soft and spongy that he realized he needed a professional, so he called *Duradek of Georgia*.

It was evident that the leaking had caused damage to the subfloor and would potentially develop into rotting wood. After a detailed inspection of the existing deck it was clear the tile was originally installed incorrectly with little or no underlayment for waterproofing. In addition cracked grout lines allowed water to penetrate to the plywood surface finding its way to the seams and the underside of the deck.

Duradek of Georgia knew exactly how to fix the problem. They gave the homeowners a full presentation of the Duradek and Tiledek options to consider. Still unsure which option was best for them, they went to see a Duradek installation in a nearby suburb. Once they saw the simplicity of Duradek waterproofing, the choice was easy. With the owners' experience with their current tile deck, they chose to go with the Duradek solution. They were impressed with the wide selection of colors and liked the idea of a minimal maintenance deck that requires only occasional cleaning. After removing the old deck materials and laying fresh, untreated plywood, **Duradek Ultra Cork Macchiato** was installed. The homeowners are very happy with the way the new deck looks and the advantage of virtually no maintenance.

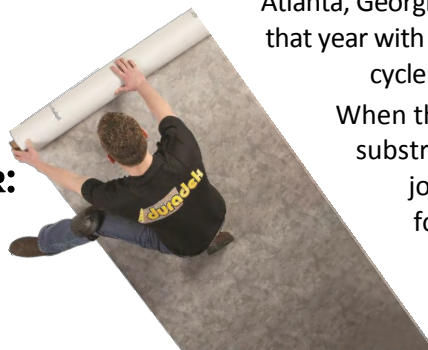
Atlanta, Georgia had experienced an exceptionally cold winter that year with three days below freezing. It is that freeze-thaw cycle that can stress exterior tiles and cause cracking. When the deck was demoed, it was revealed that the substructure was completely rotted out. New wood joist and $\frac{3}{4}$ " plywood were installed and sloped for better water management. Since the entire deck was surrounded by parapet PVC coated metal was used to make custom scuppers for drainage.
