Case History #183

Project: Plazadek System VS Adhered Tiles, Atlanta, GA Date: October 2016

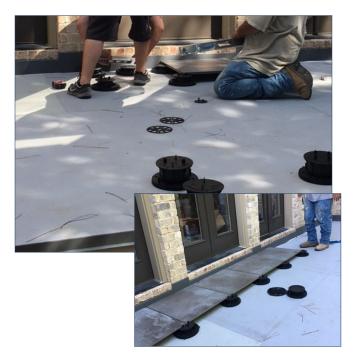
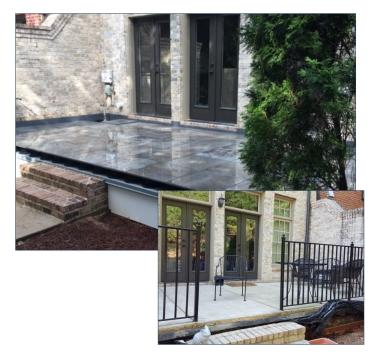
A high-end four-story/six-unit condo building had water leaking into a master bedroom below the upper tile deck. The tile installer contacted **Duradek of Georgia** for help.

A year later, a desperate homeowner now had continuing leaks from the upper deck and the lower deck was also failing and becoming soft due to rotting wood. This time an investigative inspection was completed. After a complete removal of the surface tiles on both the upper and lower decks, it was determined that the upper deck had failed due to poor details around the railing posts and fireplace. The lower deck was a tile assembly failure with substandard subfloor.

The plywood substrate was replaced on the upper deck. The lower deck was rotted and also needed to be completely rebuilt to new building codes. After the structural repairs, the Duradek membrane was installed.

The waterproofing membrane was professionally installed with drains and water routing details. The tile installer used pedestals to support the tiles. This allowed water to pass through the tiles and drain off the membrane without any moisture reaching the deck structure.
