CASE HISTORY # 148

PROJECT:
PRIVATE RESIDENCE, VANCOUVER, BC

DATE:
MAY, 2012

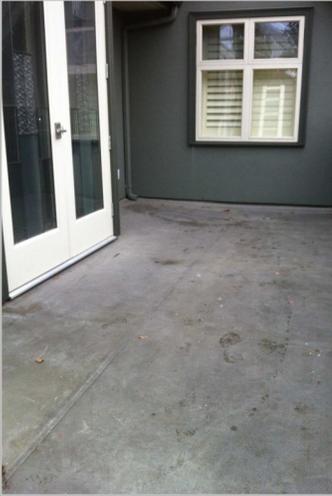
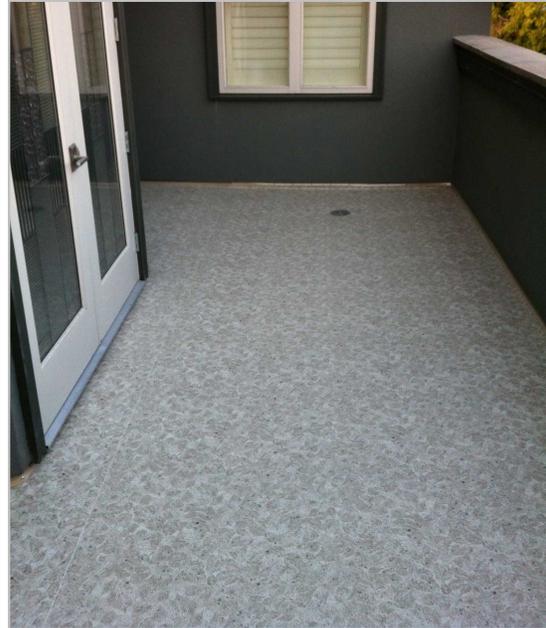
There were several issues with this existing deck. The prior owner had done repairs around the parapet wall which compromised the waterproofing, but rather than replace all of the vinyl, a decorative vinyl border was glued to existing vinyl around the perimeter and up the parapet wall to keep the waterproofing function of the vinyl intact. The wall was then finished with stucco, and both the original vinyl and border layer were eventually covered with a deck paint. The seams where the border layer met the original layer were lifting, so the vinyl had to be removed and replaced, but the project could become very costly if the recently stuccoed parapet walls and balcony door had to be removed to complete it.

The old vinyl was cut around the perimeter, leaving the original vinyl tucked up under the stucco wall with about an inch extending from beneath it. The old vinyl was removed from the deck surface and while some delamination of the plywood occurred, with some filling and sanding the plywood was able to be re-used. New *Duradek Forest Floor Birch* was applied and the seams were properly welded to provide a waterproof layer, with special care given to where the new vinyl was carefully welded directly to the old vinyl that was left tucked up under the stucco, eliminating the need to remove the stucco or the balcony door. A mechanical fastener was also used to ensure the old and new vinyl will remain securely in place, and to prevent any possible shrinkage at the deck/wall intersection.

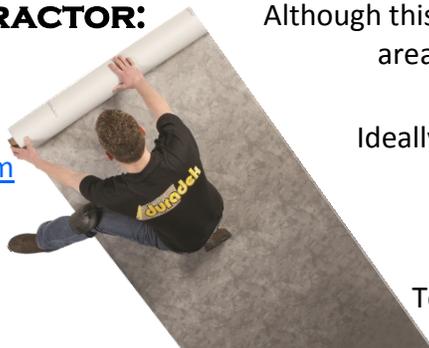
Although this was not the ideal way of waterproofing the deck area, it was an adequate solution to the homeowners problem, taking their budget into account. Ideally, removal of the stucco from the base of the wall would have been the preferred method of waterproofing the deck area, but that would have at least doubled the cost of the repair. To complete an installation like this requires a very patient, meticulous and experienced installer.
