THREE COMMON DECK COLLAPSE FACTORS AND HOW TO AVOID THEM

By Kim Smallwood, Duradek

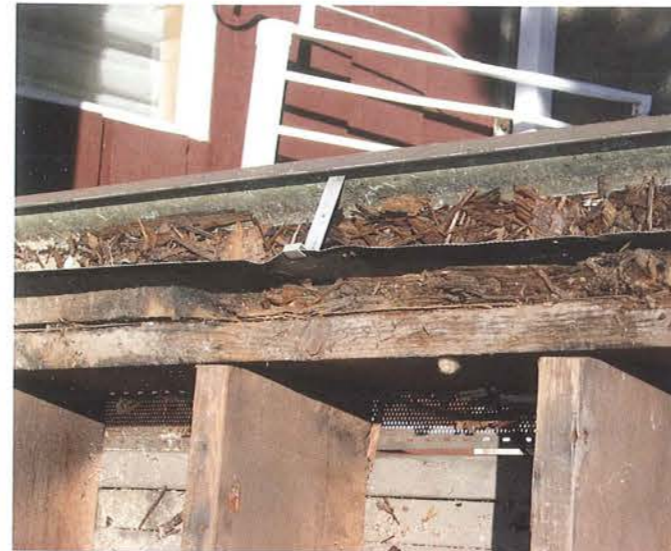
The wood rotted from water infiltration caused by inadequate waterproofing.

The most common point of vulnerability in deck collapses is where the deck meets the building. Either the ledger board that attaches the deck to the house pulls away, or the deck pulls away from the ledger board. While sometimes it is inadequate material used (e.g., nails instead of appropriate hardware and fasteners), most times the original construction was completed properly, but the wood was subsequently weakened from water infiltration that allowed fasteners to pull out. Once again, inadequate waterproofing is the culprit in the decks becoming vulnerable to collapse.

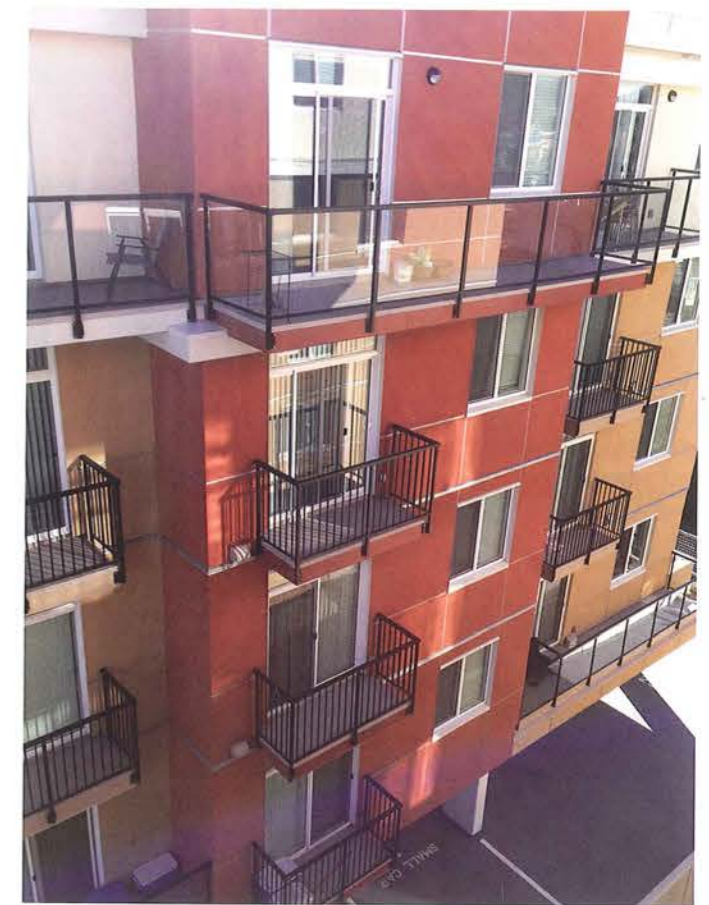
These balconies are covered in a vinyl membrane: attractive, low maintenance, and safe.

The use of a heat-welded PVC membrane gives you the longest lasting waterproof performance that requires no maintenance. After a one-time installation, vinyl decking will perform its waterproofing for decades with absolutely no recoating ever required (only a seasonal cleaning is recommended to maintain an attractive appearance).
