## Case History #110

Kingston Apartment Complex  
& Parking Garage  
20 Elmwood Street,  
Kingston, Ontario K7M 2Y5

June 1996

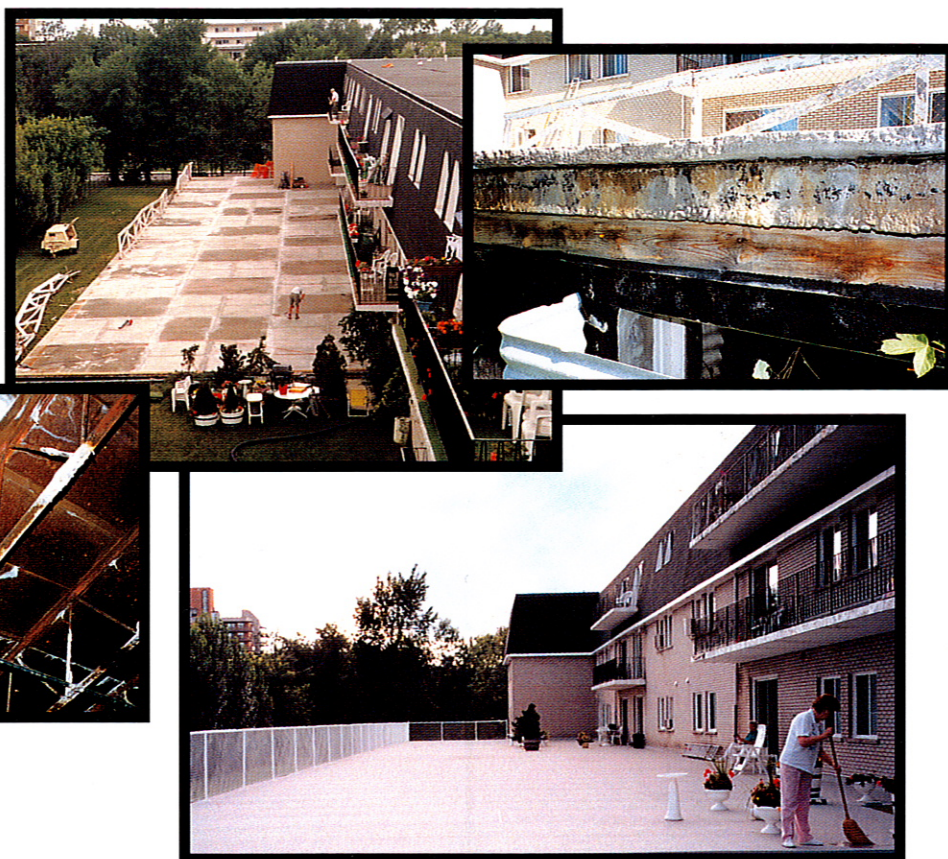
This 35 year old apartment complex had an underground parking garage that was leaking. The original waterproofing was a "between-slab" roofing membrane which had failed. Tenants were forced to build tarp structures over their vehicles to protect them from dripping water. Steel structural materials were at risk because of all the water. The deck surface over the garage, which many of the tenants looked onto, was an eyesore.

**DURADEK® COMMERCIAL.** Original surface was ground down, then levelled off with an acrylic modified cement. Duradek® was then applied over the entire surface and 6 inches up the wall, where it was mechanically terminated. The outside perimeters were turned over 6 inches as well, which was enough to cover the entire exposed edge of the concrete slab.

A completely successful solution. Water is not dripping on parked vehicles, structural metal is no longer at risk, and the tenants can now enjoy a more attractive and useable deck surface. Most importantly, the building owner avoided a possible structural disaster, which could have been, not only costly, but extremely dangerous.
