CASE HISTORY # 123

PROJECT:
PRIVATE RESIDENCE
FRUIT HEIGHTS, UT

DATE:
FALL 2010

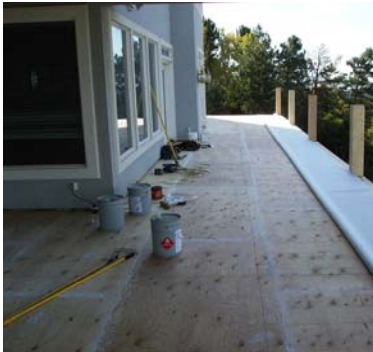
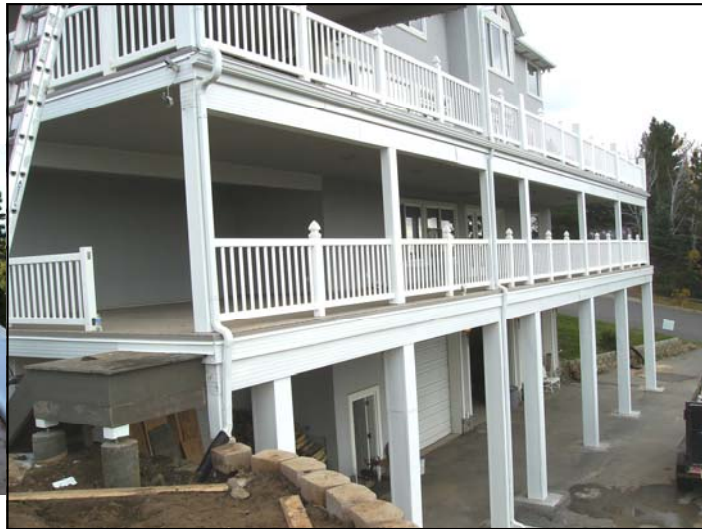
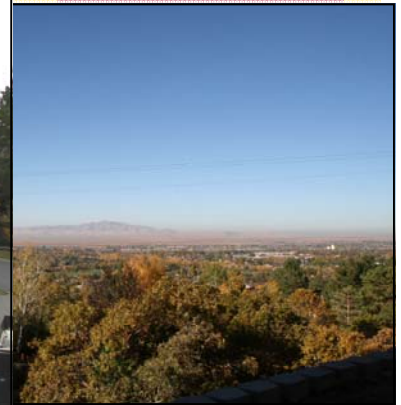
The large decks on these homes had been covered with indoor/outdoor carpeting. There was a rubber mat installed underneath but moisture found its way into the wood underneath and the carpet held it there. The deck began to rot and serious damage was done to the home. What the homeowner thought would be a small repair turned into a very significant one.

Duradek Heritage Sienna was a great compliment to the homes color scheme. The OSB substrate was removed and replaced with 3/4 tounge and groove plywood. This provided an excellent substrate for this wonderful outdoor entertaining area. There was such extensive damage from the water trapped under the carpet that even some of the posts had to be replaced. Once the Duradek was installed the homeowners were able to enjoy their incredible view of the valley.
