CASE HISTORY # 137

RESIDENTIAL CONCRETE DECK REPAIR PARK CITY, UT North America's premier waterproof vinyl flooring systems. Since 1974

DATE: JUNE 2012

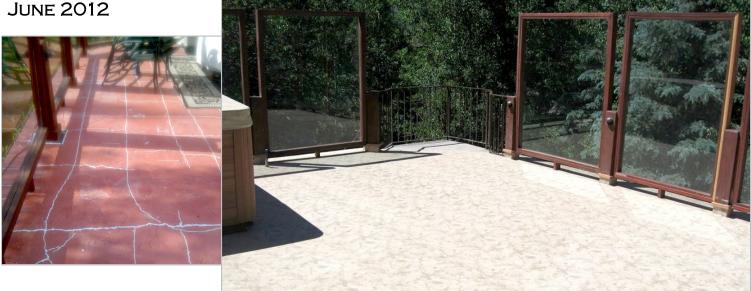
The original surface of this radiant heated deck was a stamped concrete finish that failed, and the home owner's first attempt at a solution was to paint over it...but that failed too.

Their second attempt at a solution was to fill in the cracks with caulk; and while that may have slowed the inevitability of water invading the structure, it did not resolve the problem and it was certainly not an attractive finish.

The owner of this home wanted to know if Duradek could be installed on his radiant heated concrete roof deck. After a year from the initial inquiry, he had a Duradek installer come out to resolve the issue.

The installer first used a sander to remove all of the ridges and bumps on the surface, then professionally installed Duradek Ultra Marble 'Mocha' to protect this roof deck that is directly over top of living space.
