CASE HISTORY # 141

LA CAILLE PROPERTY
SALT LAKE CITY, UT

DATE: JULY 2012

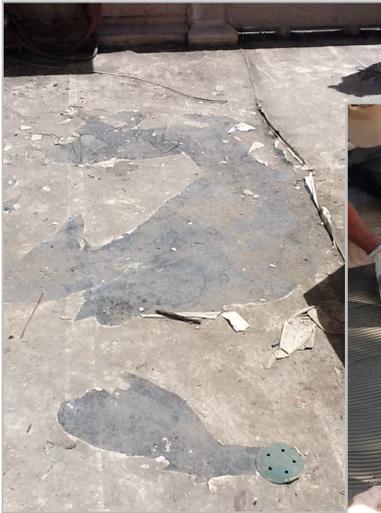
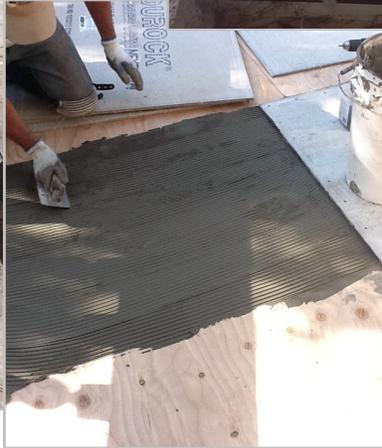
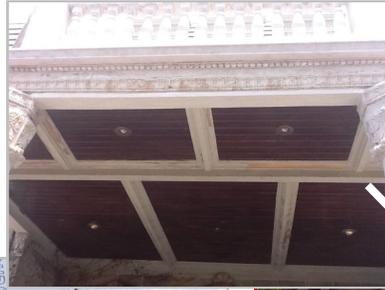
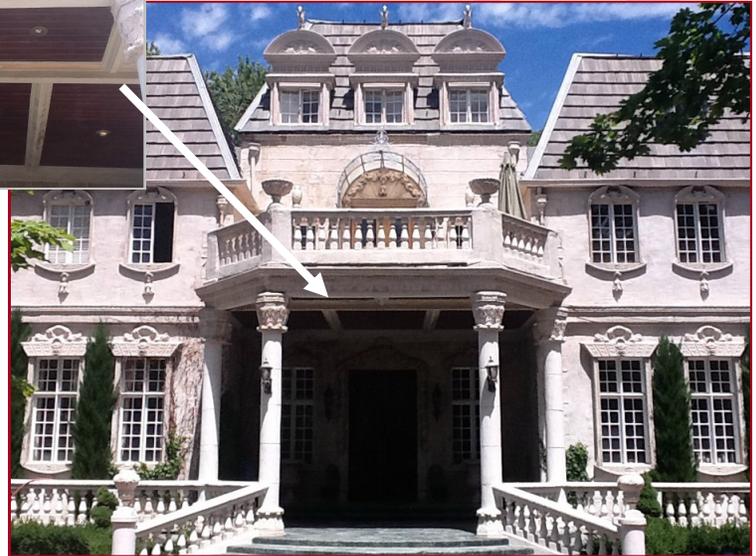
This well-known property has a rich history which sadly includes a failed roof deck. The deck was originally covered with EPDM, but since that is not a walkable surface, it was then inadequately coated over with what appeared to be a thick paint.

To complicate matters further, the EPDM was not fully adhered resulting in ripples and rolls in the deck, and the paint coating was only applied to the non-level EPDM. Even further shoddy workmanship was shown as it was discovered that a power line was laying across the deck and was simply covered over with the EPDM which caused the ripples.

The Duradek dealer, Aspen Roofing, cut away the damaged substrate, replaced it with new T&G 3/4" plywood and used a 1/4" notched trowel to apply a bond coat of thinset. Then a 1/2" Durarock CBU was screwed down and finally the Tiledek membrane was fully adhered with D763 latex glue, making the project ready for the tile installers.

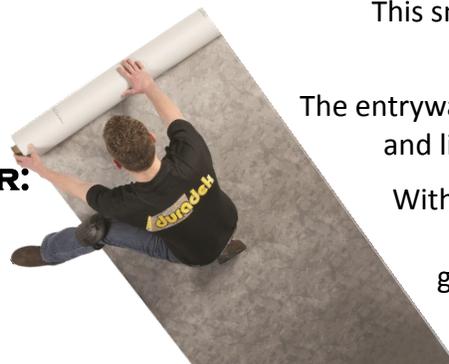
This small deck serves as the roof for the entrance to this beautiful house.

The entryway was designed with a wood soffit and lighting that needs to be protected.

With Duradek Ultra Tiledek waterproof membrane, the deck now provides guaranteed roof top protection and the entrance's lighting and soffit is safe from water damage.
