# CASE HISTORY # 157

**PROJECT:** 2ND LEVEL DECK RENOVATION - ATLANTA, GA  
**DATE:** MARCH, 2014

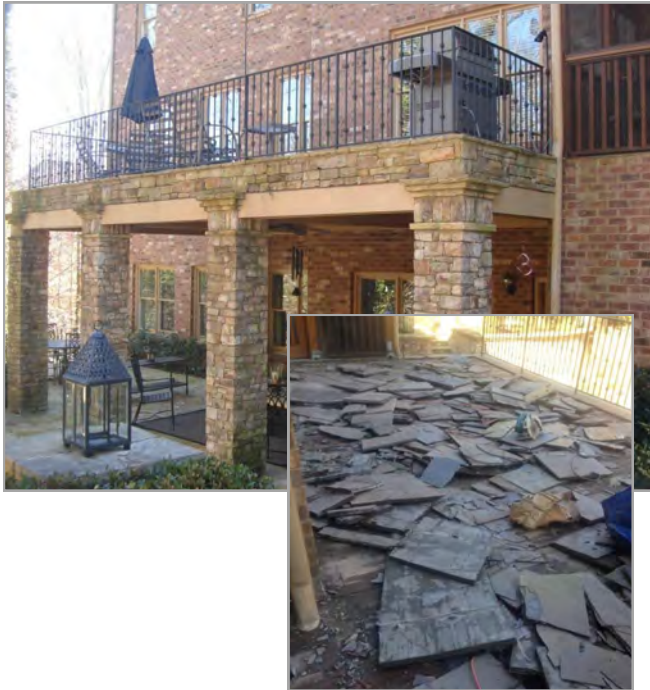
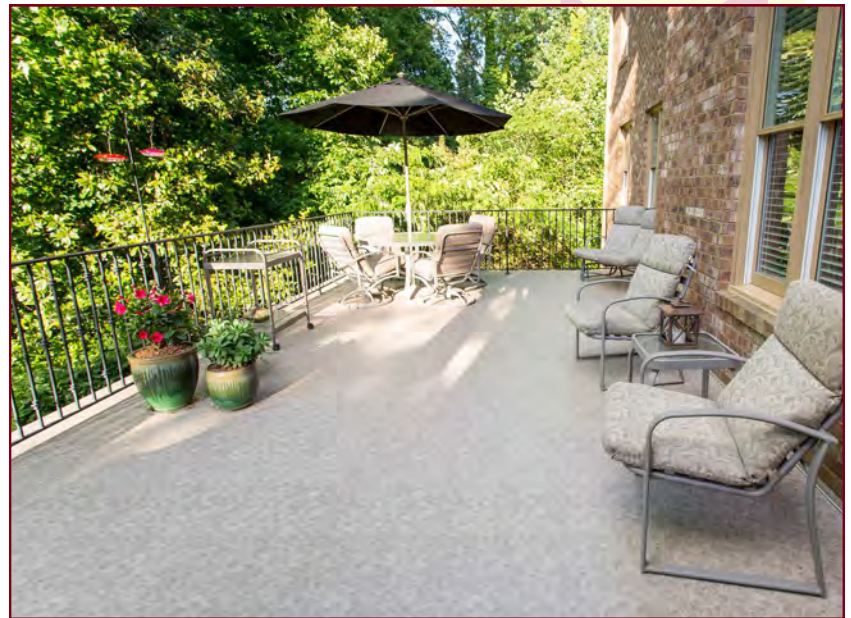
This home owner had a beautiful tile deck on their original construction, but it was not built with proper waterproofing materials or any kind of anti-fracture membrane. Water continued to leak through the cracked grout to the subsurface, and eventually to the underside damaging the deck structure's original substrate and foundation.

After years of unsuccessfully trying to seal the deck using liquid sealants, the leaking continued to do further damage. Looking for a permanent solution to this problem, the home owner found Duradek's website.

After investigating the tile deck and the underside damage, the customer was given 2 options for roof grade waterproofing. First, they would need to remove the tile and subfloor, replace it with 3/4" T&G plywood and slope the deck for water drainage. Then they could either install a.) Duradek Vinyl Membrane; or b.) Tiledek Membrane and re-surface with tiles.
