Case History #175

Project: The Lofts At Mercer Roof Decks | Macon, GA

Date: May 2017

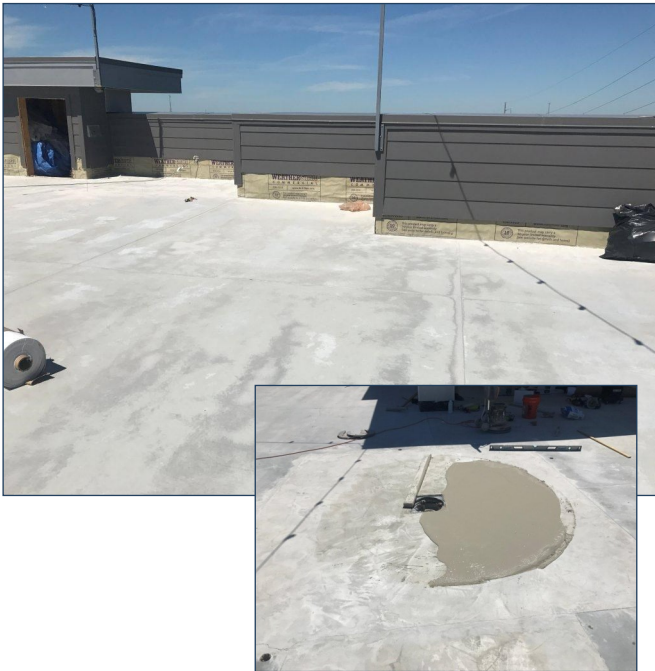
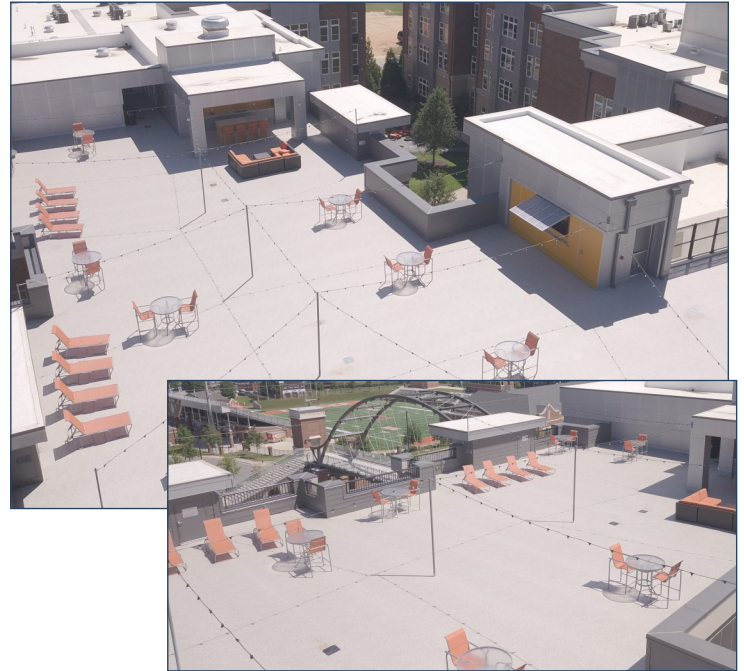
With construction underway, just 10 days before the planned Duradek installation, the building owner decided to go a different route with the waterproofing of the massive rooftop deck. The assembly was a solid base of $\frac{3}{4}$ " T&G plywood as the subbase, a $\frac{1}{2}$ " sound blocking product, and a 2" concrete surface. However, for the waterproofing component, they sealed the roof with a liquid coating which almost always fails without regular reapplication due to cracking.

Within two years, the property manager placed an urgent call for **Duradek of Georgia** to revisit the project. The roof deck was leaking into the floors below causing damage to the building.

After the property manager consulted with **Duradek of Georgia**, both parties agreed the first step was to prepare the roof deck surface for the Duradek membrane. This involved the labor intensive task of grinding off all of the failed liquid coating. Then surface leveling compounds were applied to ensure water was routed towards drains which were placed to meet the local building code requirements.

Once the surface was properly prepared, **Duradek Heritage Agate** with cool roof qualities was installed. Applied with adhesives and heat welded seams to fully join the 6 ft width of the vinyl sheets, Duradek provided a completely water-tight seal. The membrane was integrated into the building envelope by running the membrane a minimum of 8 inches up interior perimeter walls between the building paper and the cladding.
