Case History #185

Project: HGTV Railings Upgrade, North Vancouver, BC
Date: June 2019

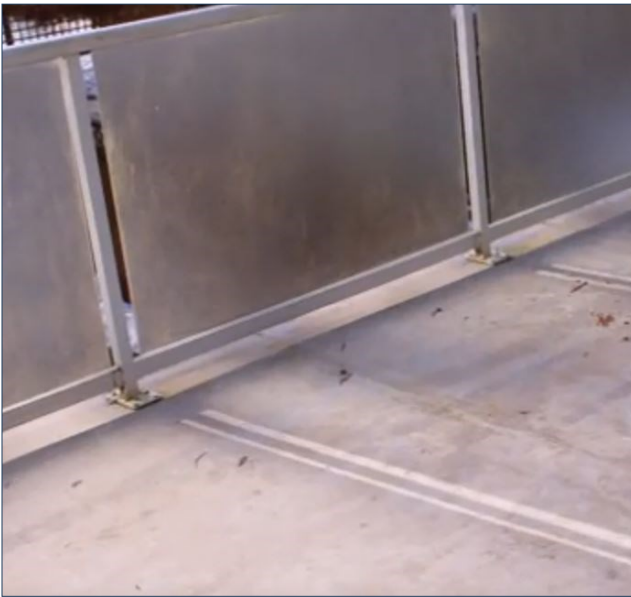
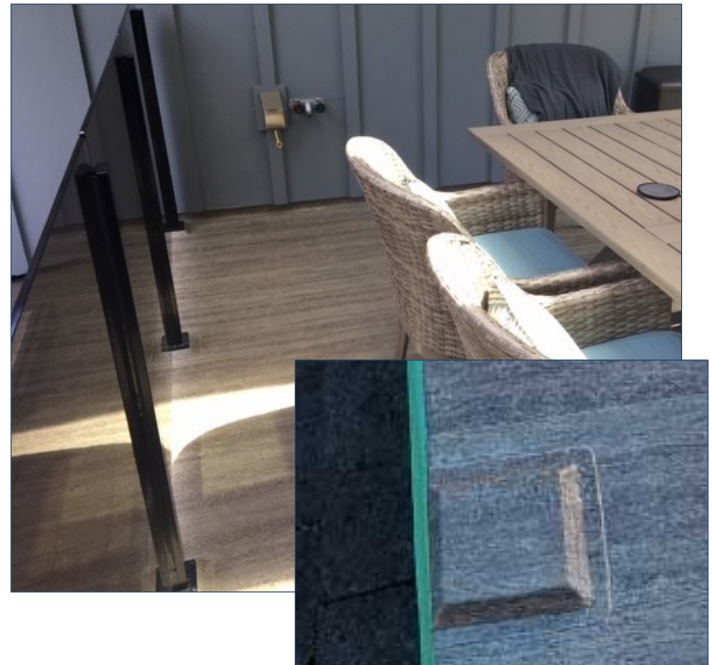
This deck surface was against a sloped garage roof, leaving no fascia for the railings to mount to. The railings were surface mounted and bolted right through the deck waterproofing. This left the garage below vulnerable to leaks and water damage.

For the most effective waterproofing with surface mounted railings, the Duradek installer incorporated raised base plates. When railing posts are secured to raised base plates, water cannot settle where the screws secure the posts, a point of waterproofing vulnerability.

Base plates were cut from PVC composite wood and placed on top of the vinyl membrane where the railing posts would be installed. A 1/2" hole was placed in the vinyl below the base plates to allow for vapor diffusion in the event moisture did penetrate the screw chases. The base plates were finished by sealing them in the same vinyl as the deck surface by heat welding them in place.

The railing posts were then installed on top of the vinyl wrapped raised base plates with fasteners going through to the deck surface. The vinyl membrane's waterproofing integrity was intact and not compromised by the railing post mounting.
