Case History #195

Project: Boathouse Roof Deck, Coboconk, ON
Date: June 2021

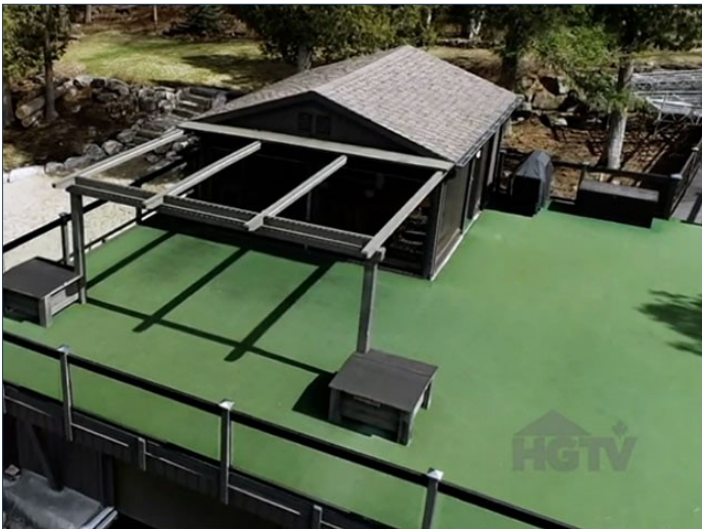
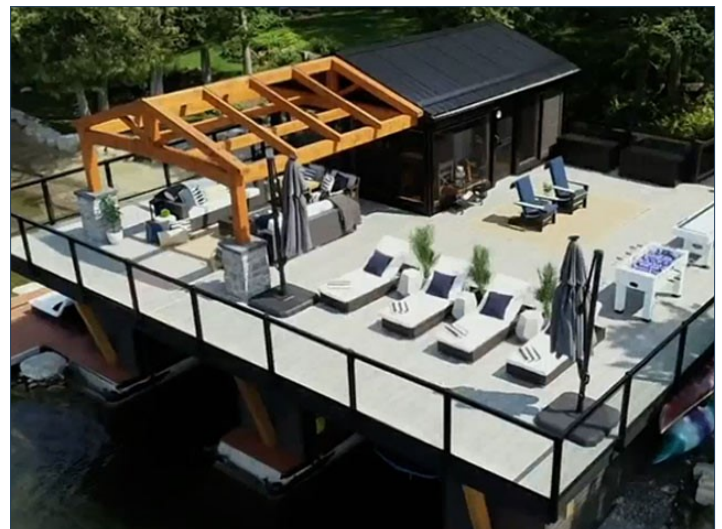
This lakeshore boathouse had a coveted 1600 sq. ft. roof deck, but it was in dismal shape. A failing membrane and an artificial turf surface made it unattractive and unpleasant to use.

The turf deck surface was saturated with moisture and had become moldy. Even worse, the waterproofing below the turf was failing. Water accumulated on the turf and eventually leaked through the failed membrane. Below the deck, the boathouse ceiling had visible mold and other signs of water leaks. The longer the leaks were left unaddressed, the more expensive the repairs from water damage would be.

When the artificial turf was removed from the deck surface, the leak issues became more evident. The moisture damage was obvious with the seams lifting and rot setting in. In the areas adjacent to full length windows and door openings (areas most vulnerable to water leaks), previous patch jobs on the membrane did not solve the leak issues and were also failing. They needed a permanent solution.

First, new 3/4" T&G untreated plywood was installed at a 2% slope to allow water run off. Seams were filled and sanded to provide a smooth surface for the membrane.

Duradek™ Ultra Legacy Driftwood was installed using contact adhesive. The Duradek membrane was run up and over into the door and window sills to ensure complete waterproof protection at these critical areas with specific installation details unique to roof deck waterproofing.

Heat welding was completed along each length of vinyl with a 3/4" overlap. At the outside perimeters of the deck, the vinyl membrane was heat-welded to PVC coated drip flashing to ensure water run off would be directed away from the boathouse below.

The boathouse was now completely waterproof with a roofing membrane that also provided an attractive deck surface. No waterproofing maintenance is required for its lifespan so the easy to clean surface will remain accessible to enjoy without the need for closures.
