Waterproofing makes all the difference in dual-level deck

TileDek membrane and porcelain tile resolves long-standing water intrusion issues

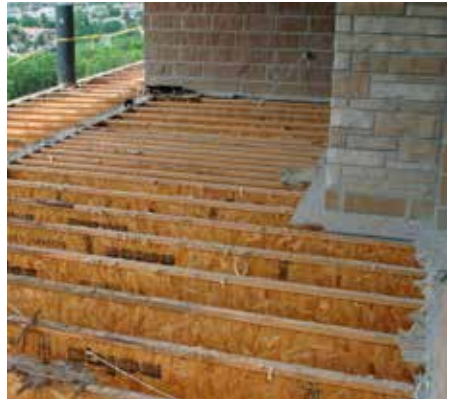
Ineffective waterproofing on upper and lower level decks in this Odgen, Utah home caused extensive water damage and the need to replace the substrate.

Unfortunately, the water damage was more extensive than originally anticipated, and the substrate had to be replaced. The flexibility of TileDek allowed the MBL to wrap the columns and prepare them for 20" x 20" Silk Crest porcelain tile from Bedrosians as a deck finish.

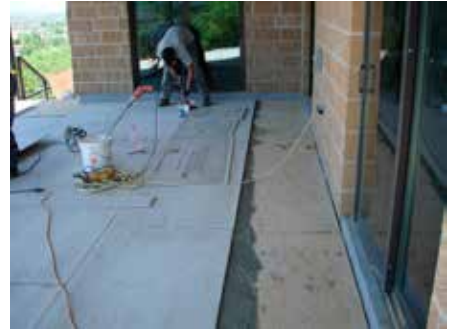
After replacing the substrate, MBL Construction readied the surface for tile by installing the TileDek membrane, tile backer and bond coat of MAPEI Ultra Flex 2 .

Work started with the lower deck over the living space and progressed quickly. As soon as the TileDek membrane was applied, tile setters installed the tile using DUROCK NextGen tile backer, MAPEI Ultra Flex 2 as a bond coat and MAPEI Granirapid thin-set mortar. The tile was then grouted with MAPEI epoxy grout and urethane caulk. The project progressed so quickly the homeowners were able to entertain on their deck at an upcoming party and have the peace of mind of knowing the water issues were resolved and they possessed a beautiful, enduring tile deck.

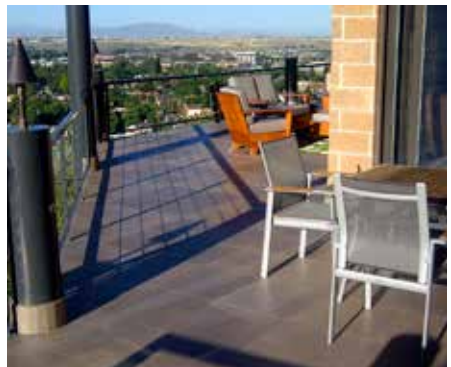
The flexibility of TileDek allowed the installer to wrap the columns and prepare them for tile installation.
