Common Sources of Failure of Tile Decks on Wood Frame Construction

By John Ogilvie - President of Duradek

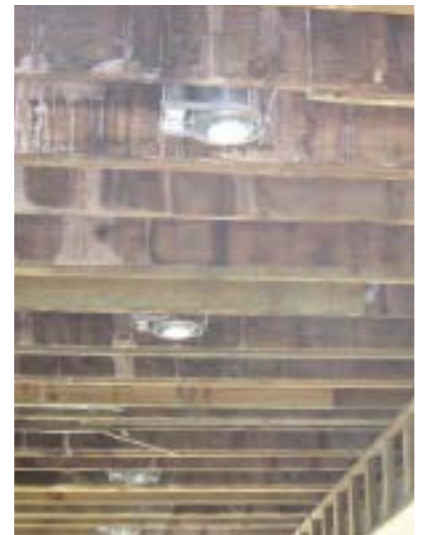
Failed Tile Job

The lack of adequate waterproofing can result in rot and structural repairs that can be extremely costly.

One of our contractors in the San Francisco Bay area recently completed a repair of a failed tile job that involved a new ceiling, replacement of rotted floor joists, door removal and obviously a whole new tile installation, this time with an appropriate roofing membrane protecting the house. The problem? There was a waterproofing membrane present, but it was not a roofing membrane nor was it installed with “roofing” details and most likely by the tile setter who never professed to be a roofer. The

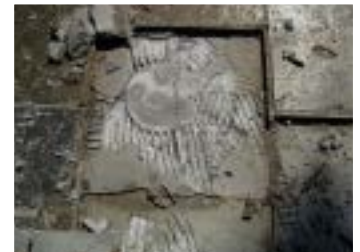
Thinset Coverage Should be 100%

100% coverage of the thinset: Voids in the thinset coverage will provide space for moisture to collect. While difficult to completely avoid air spaces, the goal is to get 100% coverage of the bonding adhesive.

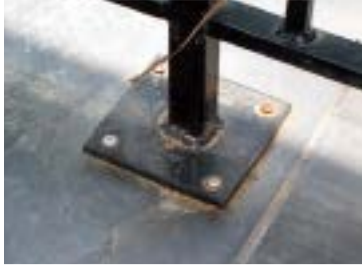
The fasteners required to hold the rails will penetrate the roofing membrane. Water flows on top of the waterproofing membrane. Any penetration of the membrane will be almost impossible to seal and at any rate, is a very bad practice.

Surface Mounted Railing

The other issue with a surface mounted rail relates to the likelihood of cracking the tile as you tighten the fastener.

The best practice is to mount the rails on the fascia or on a curb. Details can be seen at duradek.com/DurarailCADdrawings.
